PHOTO LOG**W 13008**

Wesco/Lander field

SPCC Inspection 6 June 2013

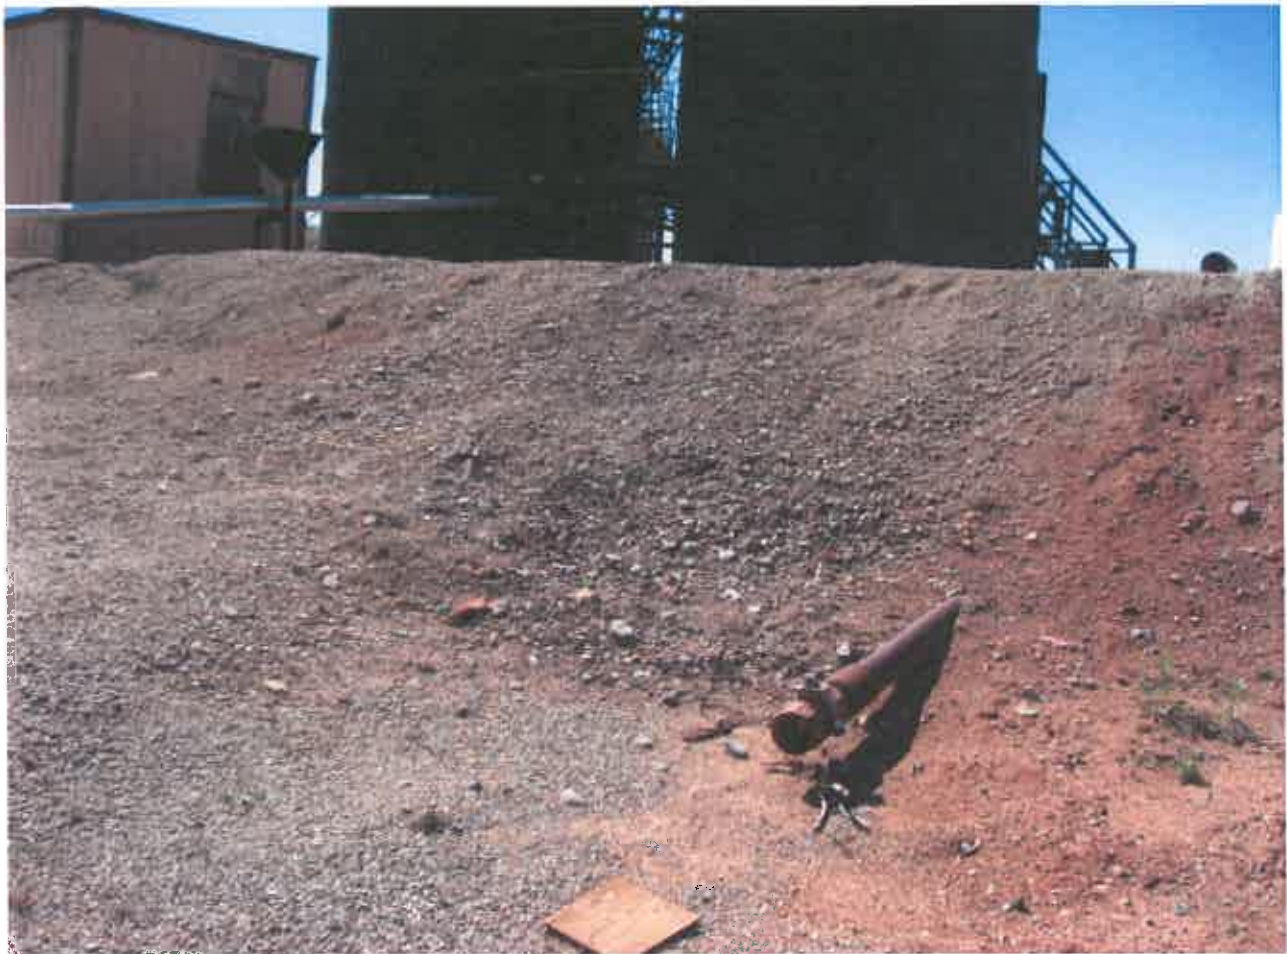
19: Drain pipe from secondary containment basin at insulated heater ASTs.
WESCO/ Lander field **W 13008** 6 June 2013

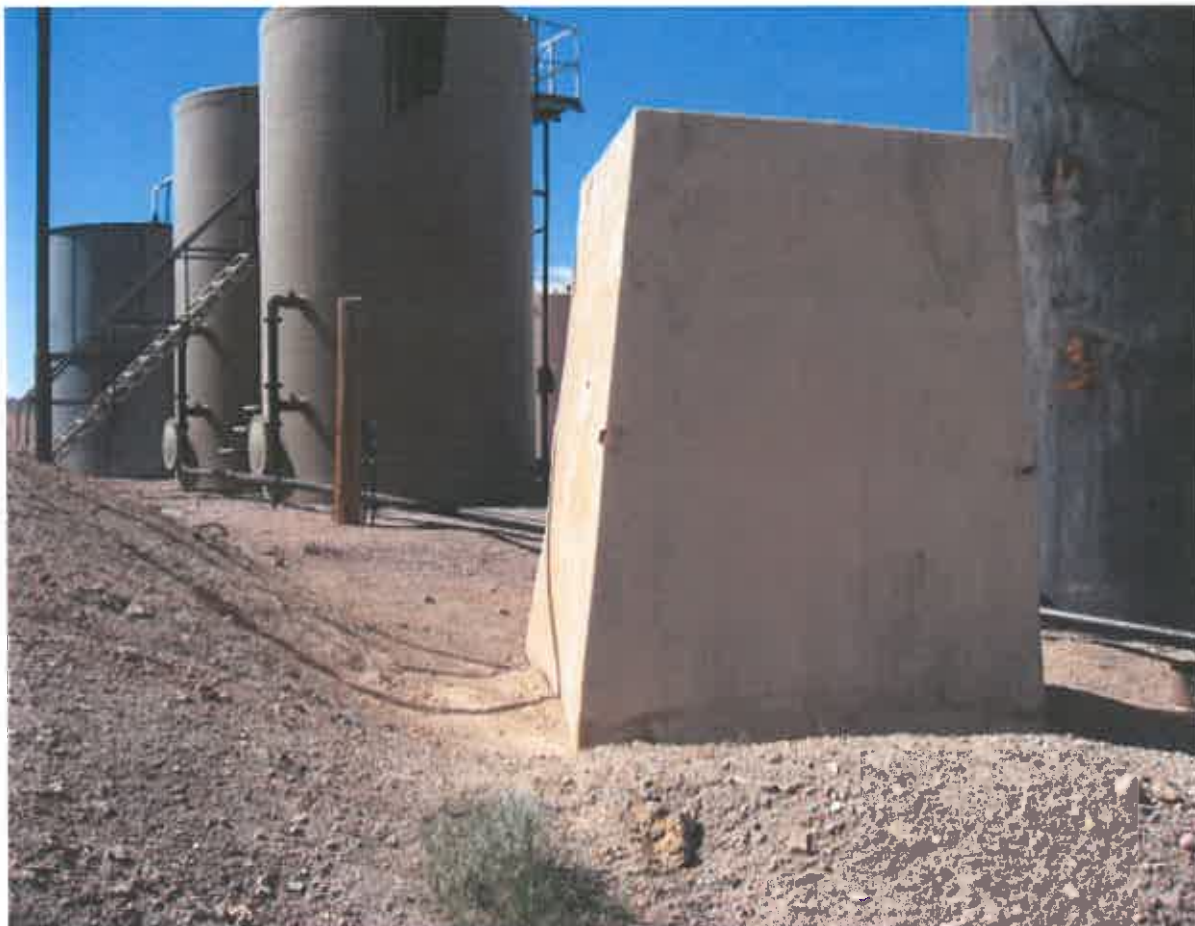
20: View of two new ASTs, with bolted steel water AST in background.
Foreground is anti-freeze heat shed utilized in oil cleanup/recycle process.
WESCO/ Lander field **W 13008** 6 June 2013

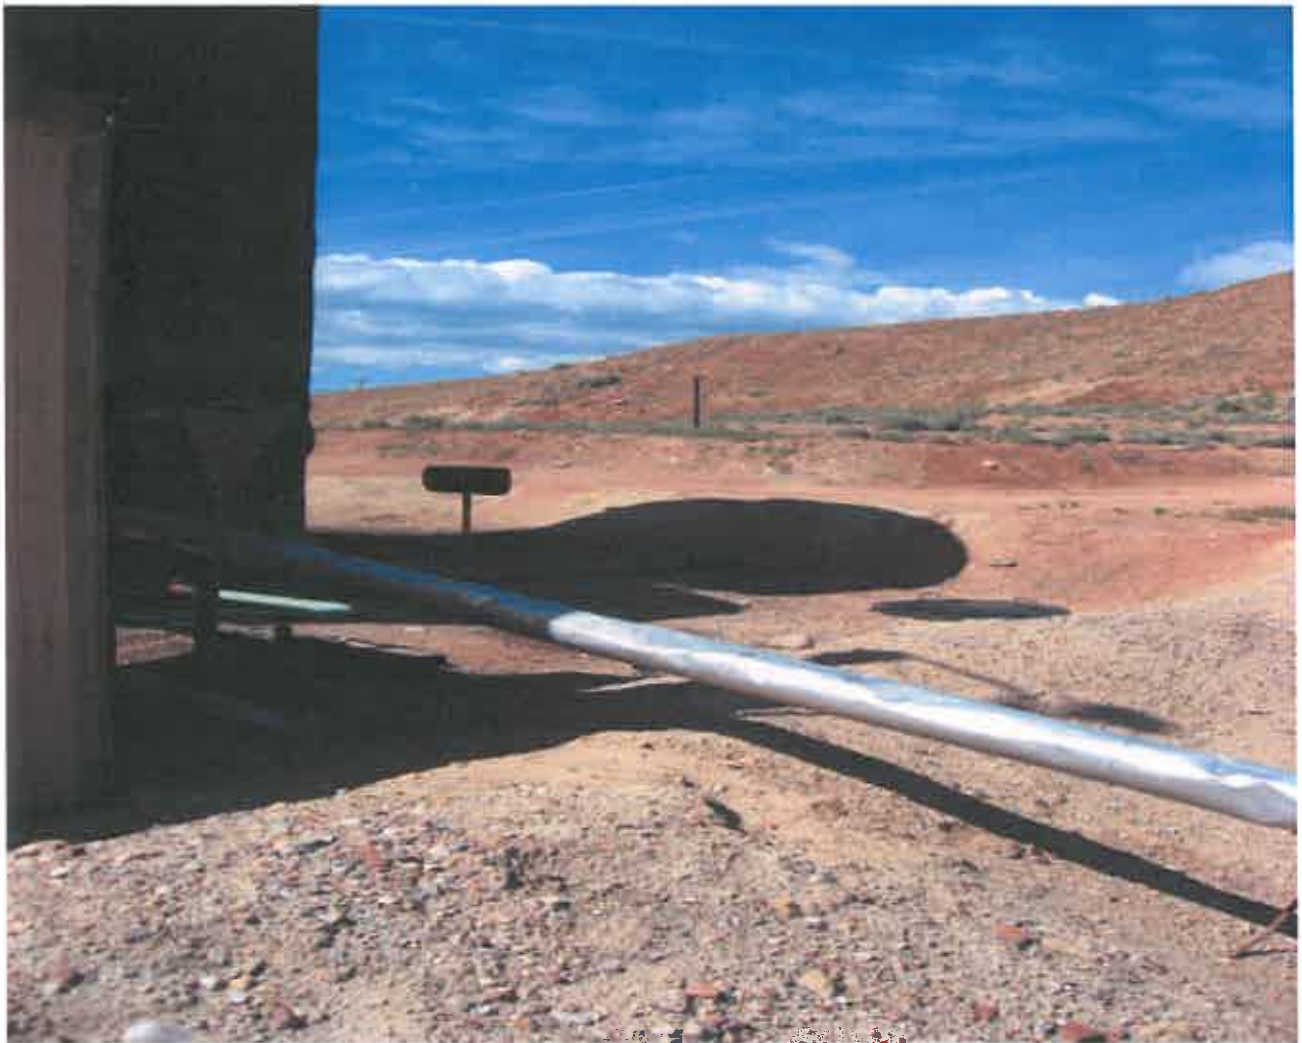
21: Insulated piping which is part of heated "bad oil" treatment process.. Note Sump cover with dual handles within secondary containmnet area.
WESCO/ Lander field **W 13008** 6 June 2013

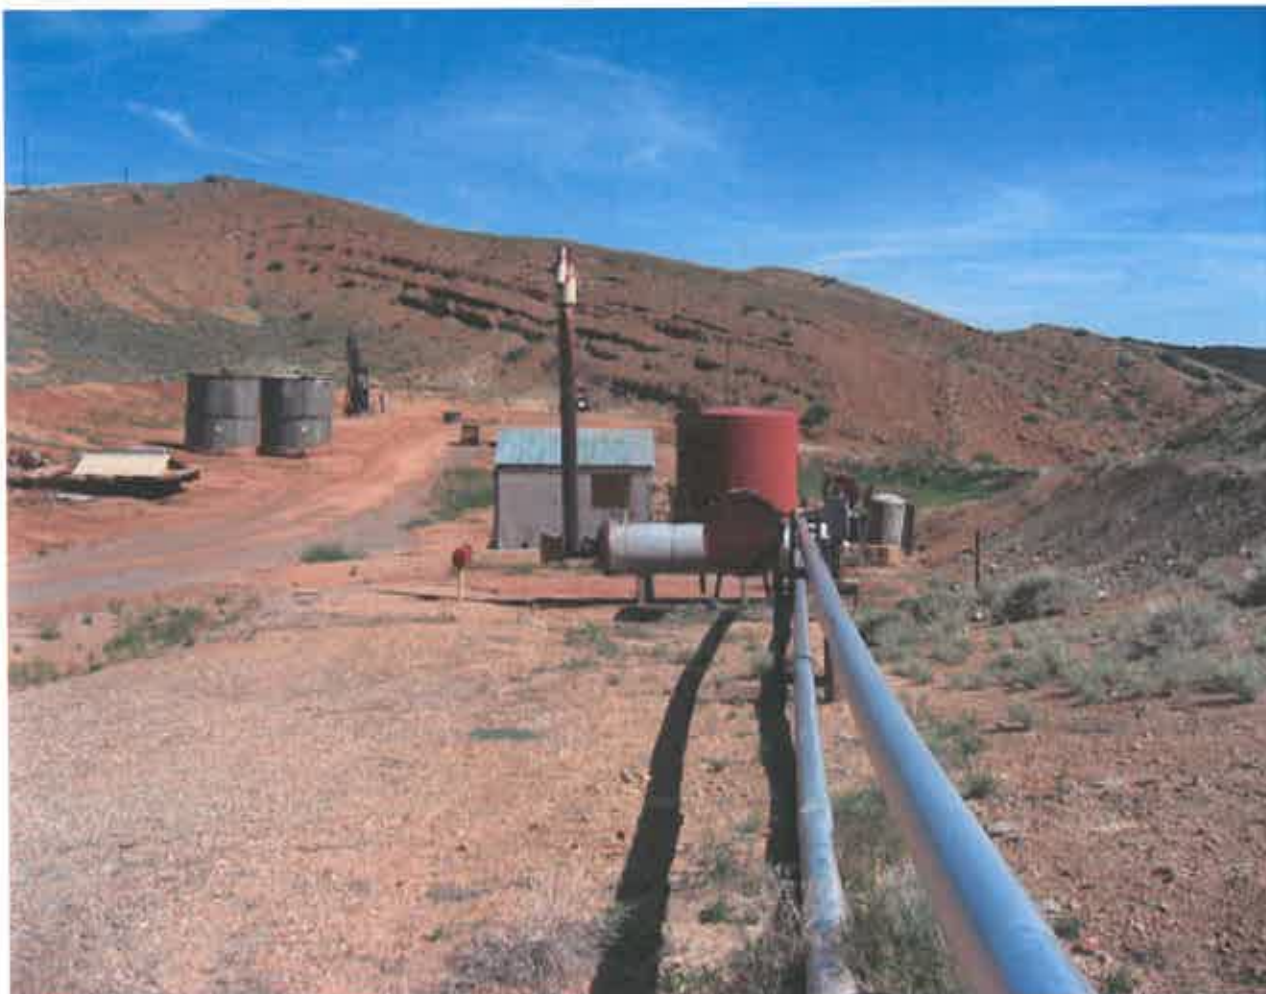
22: Insulated pipelines from flare, small heater treater which runs on to "bad oil" treatment system.

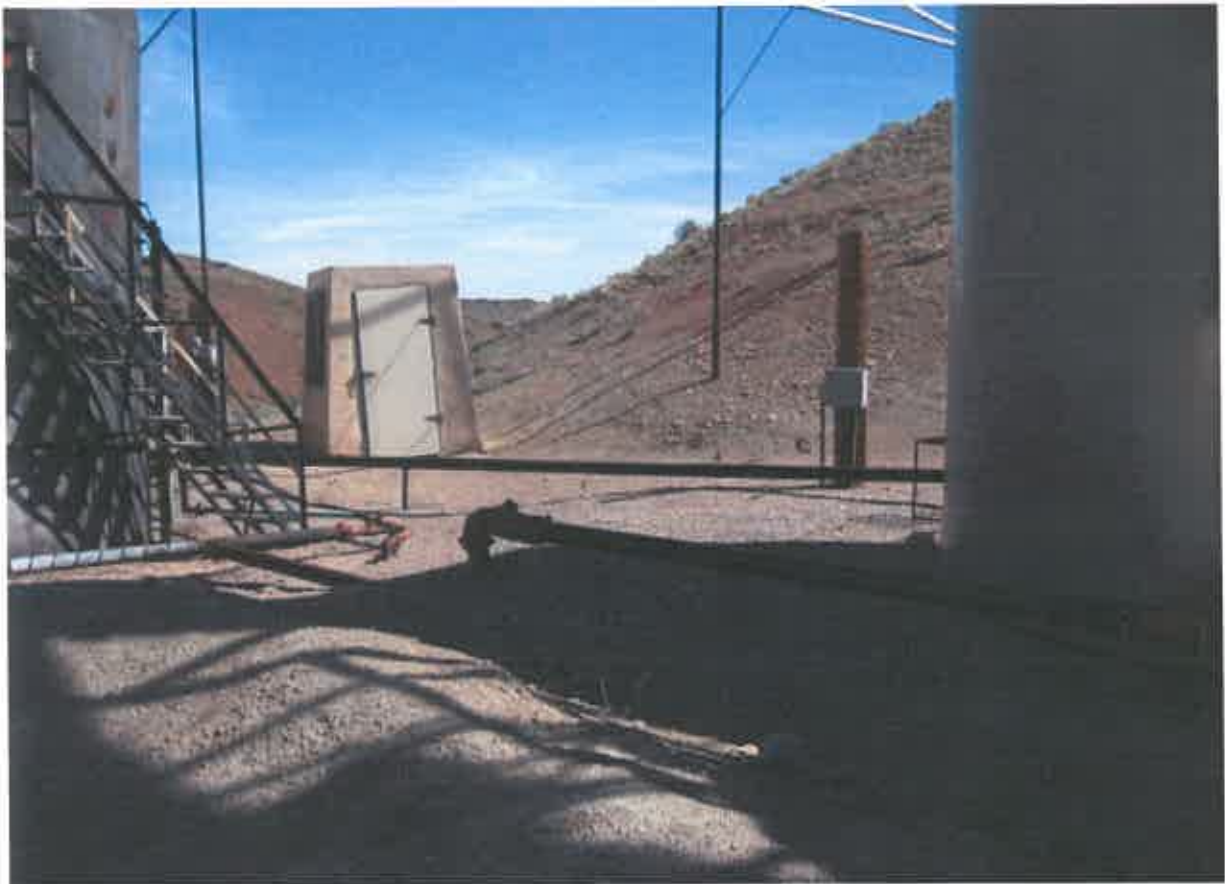
23: Anti-freeze heat shed , part of “bad oil” process that cleans out, recycles good oil and produced water.

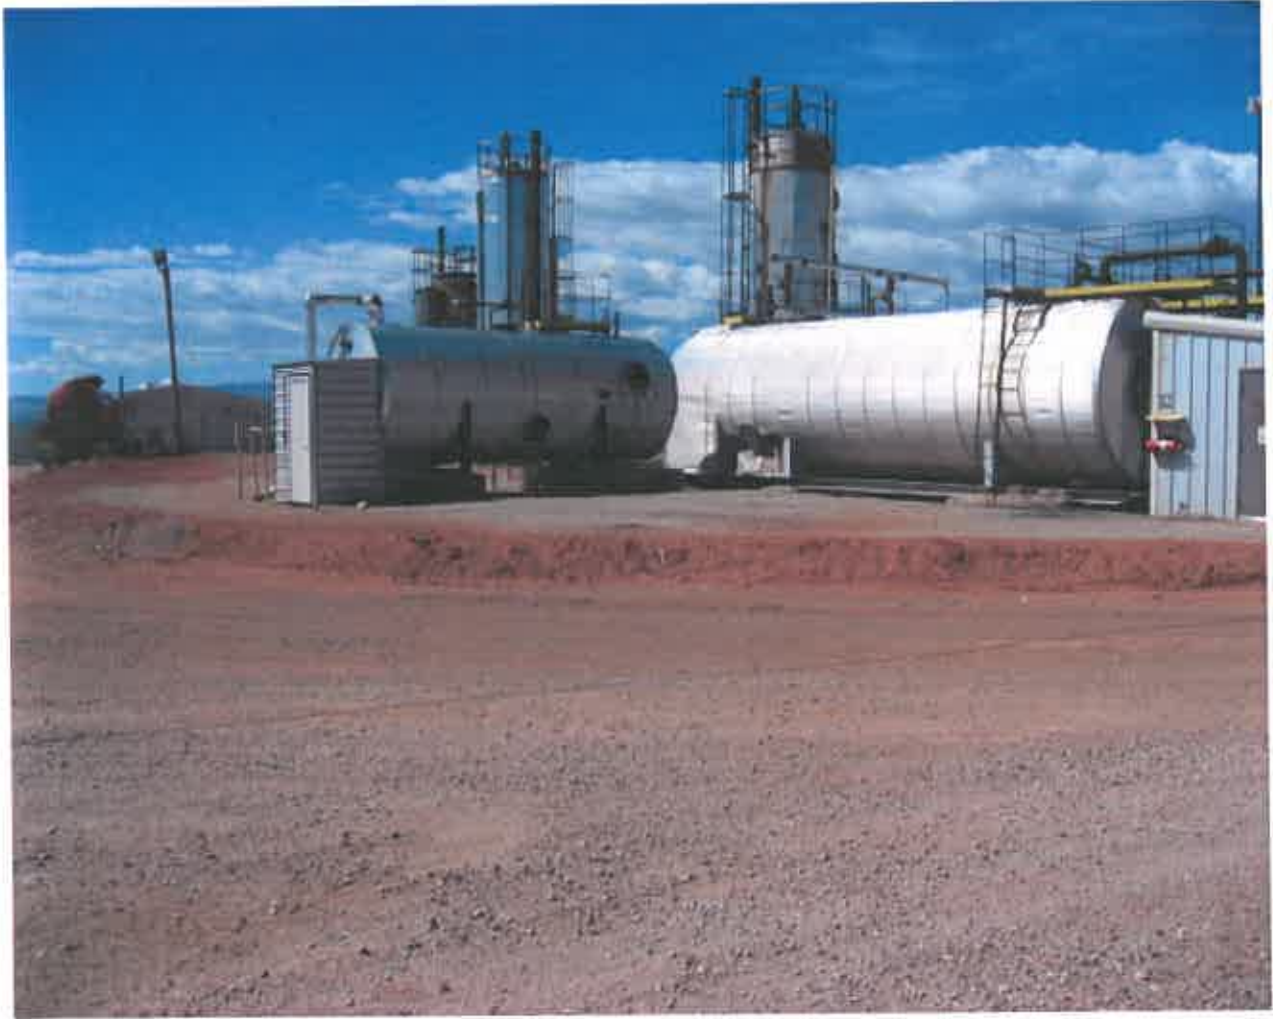
24: View of three vertical heater treaters; Indian LPU Treater 6' X 21' 106 bblWS in background; PA West LPU Heater treater #2 251 bbls and PA LPU Treater #1 6' X 27' 136 bbls. In fore ground Indian FWKO 8' X 20' WS 180bbls, then West LPU FWKO #2 10' X 30' 420 bbls. View perspective is southwest.
WESCO/ Lander field **W 13008** 6 June 2013

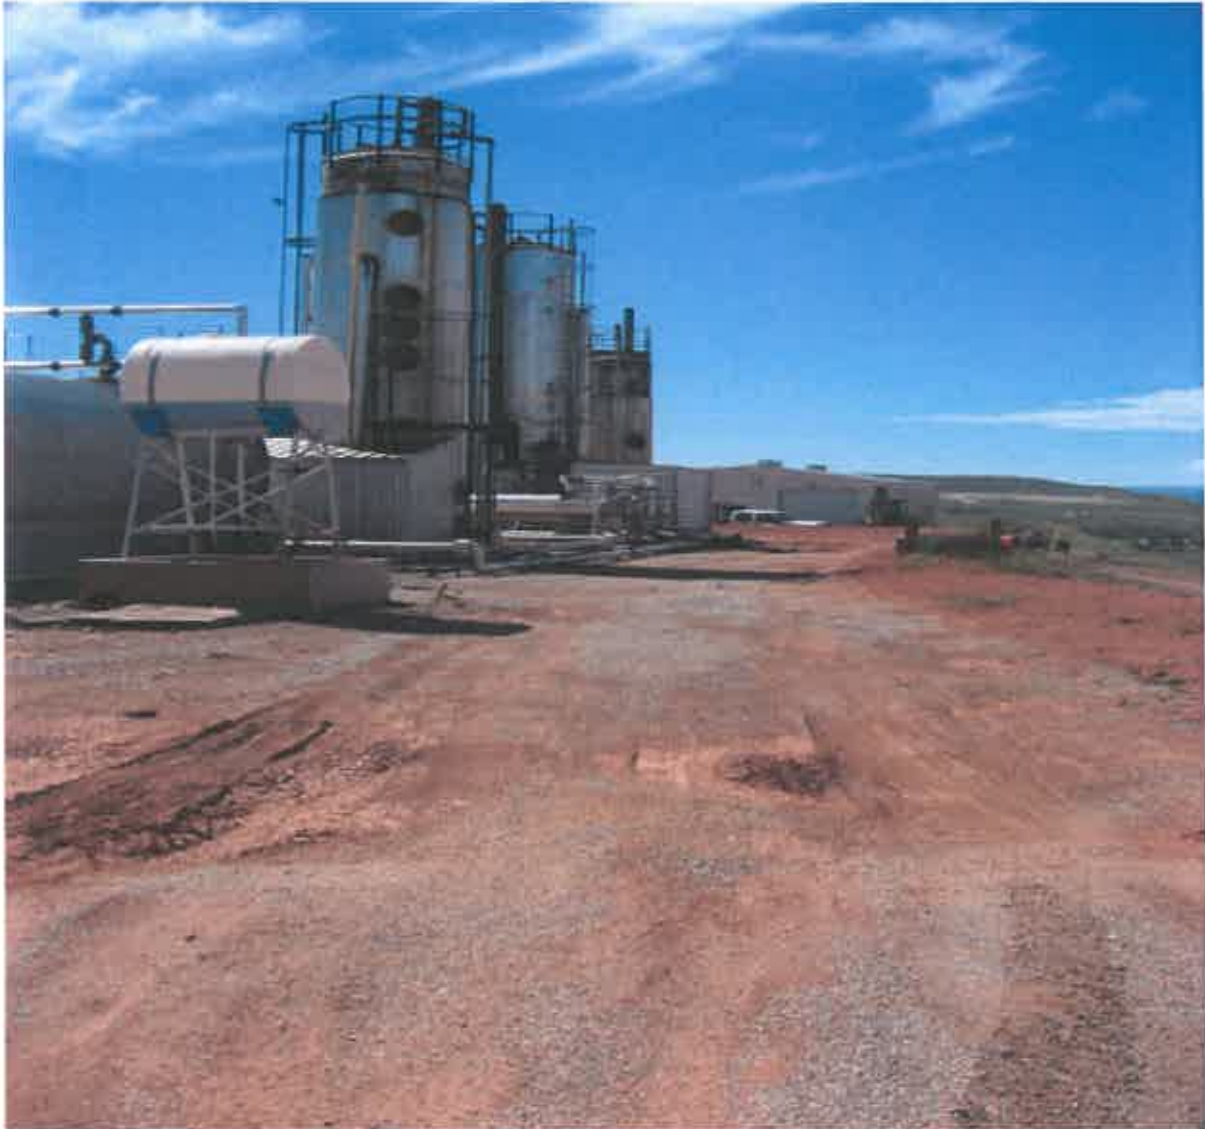
25: The three heater treaters in southern perspective . Dirt berm wall to right of photo plus elevated plastic chemical tank which holds 500 gallons.

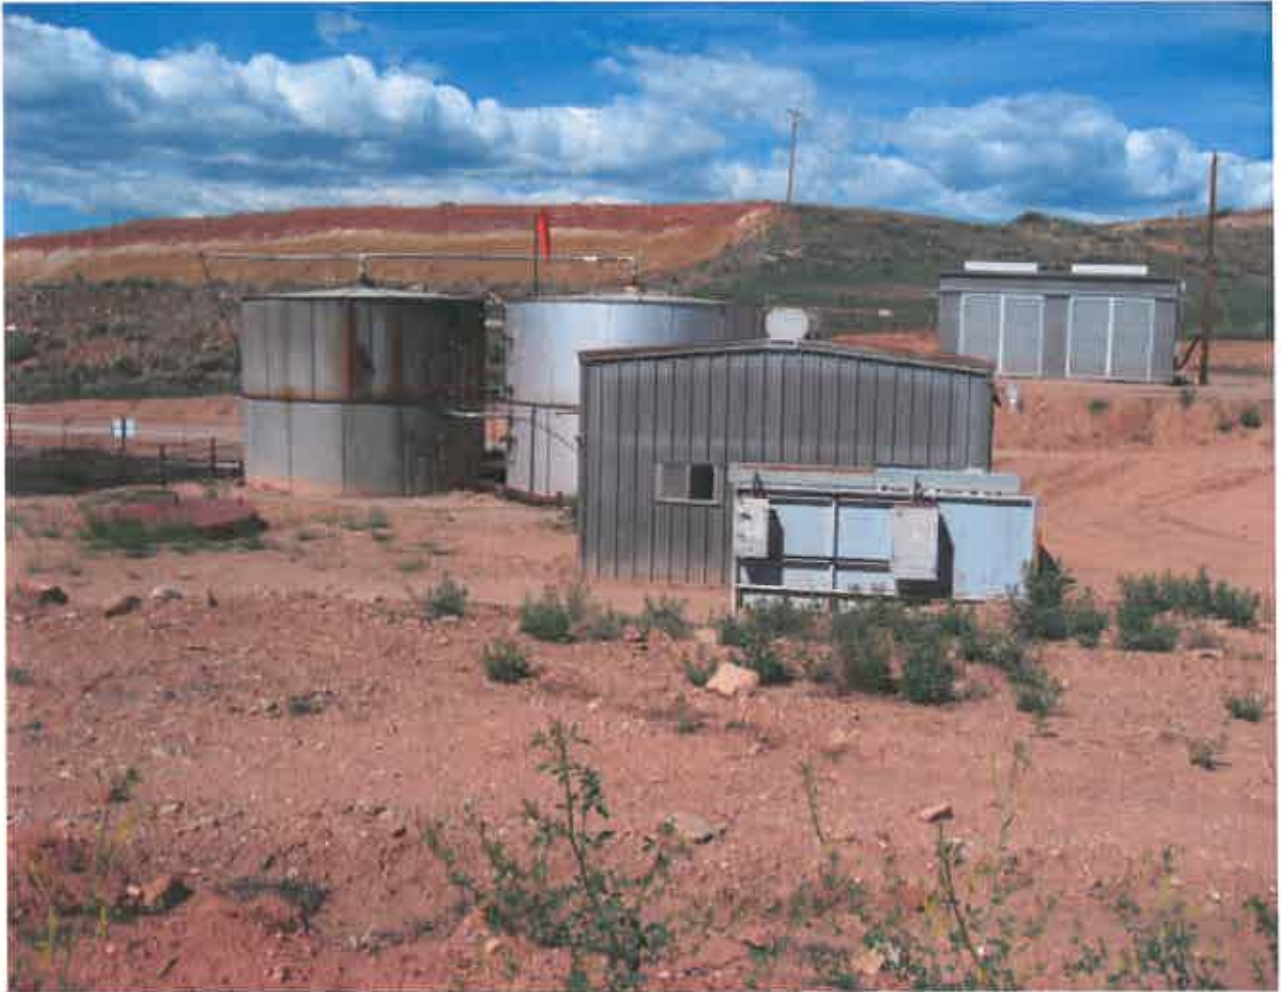
26: View of two 1000 gallon produced water ASTs, field constructed steel bolted, sitting just above the concrete screened evaporation/storage pit. Shed in foreground is PA (private lands lease) header house, with electronic control panel in view. Perspective is west/sw.

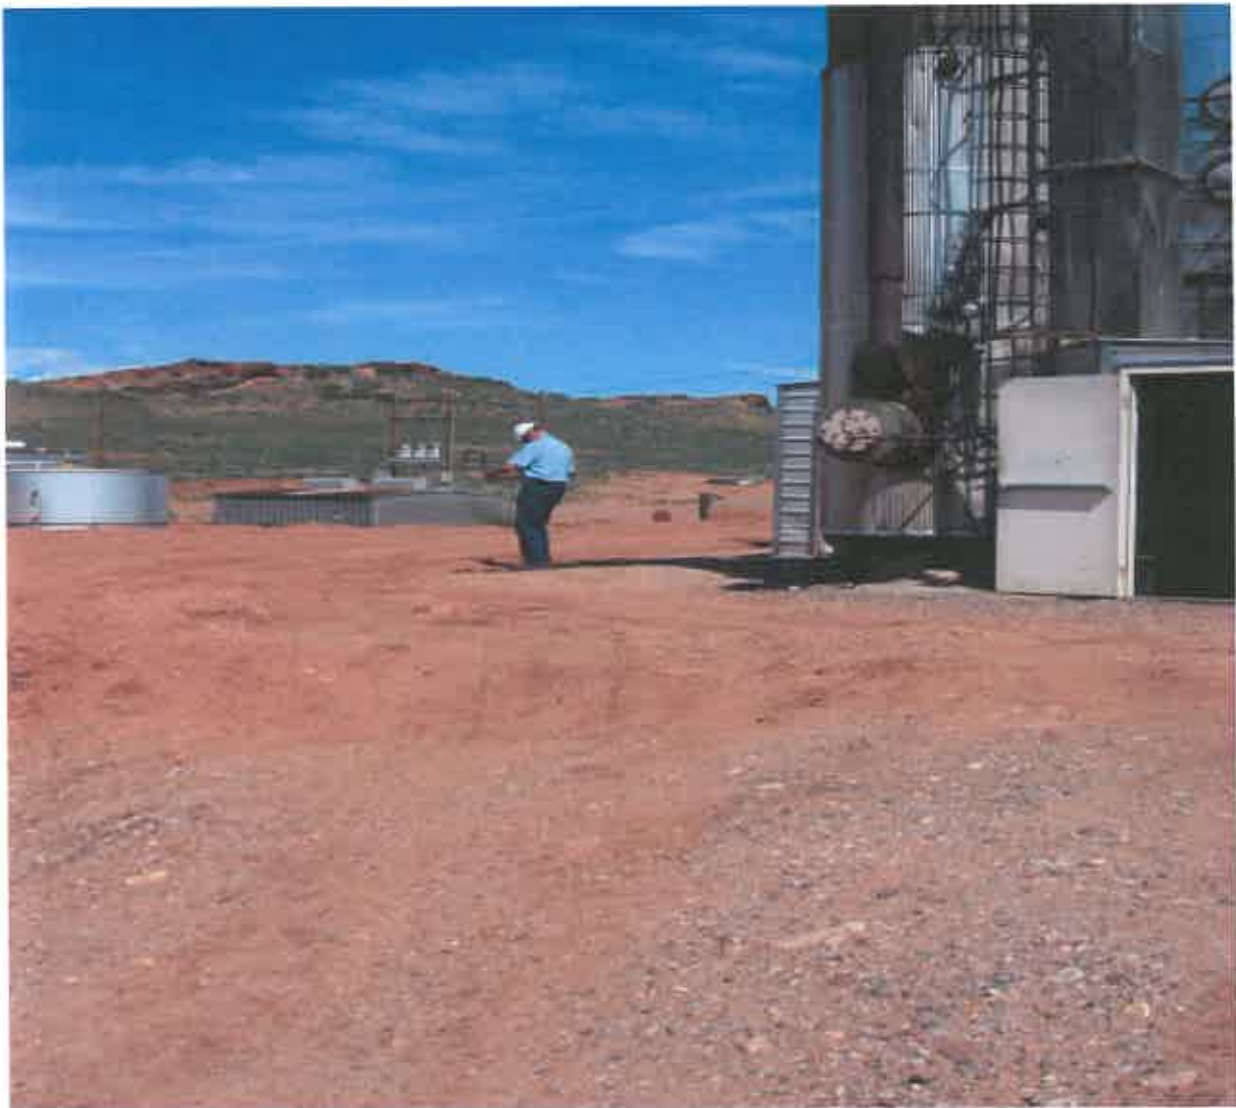
27: Perspective of Indian LPU heater treater looking to northwest with tops of produced water ASTs in background.

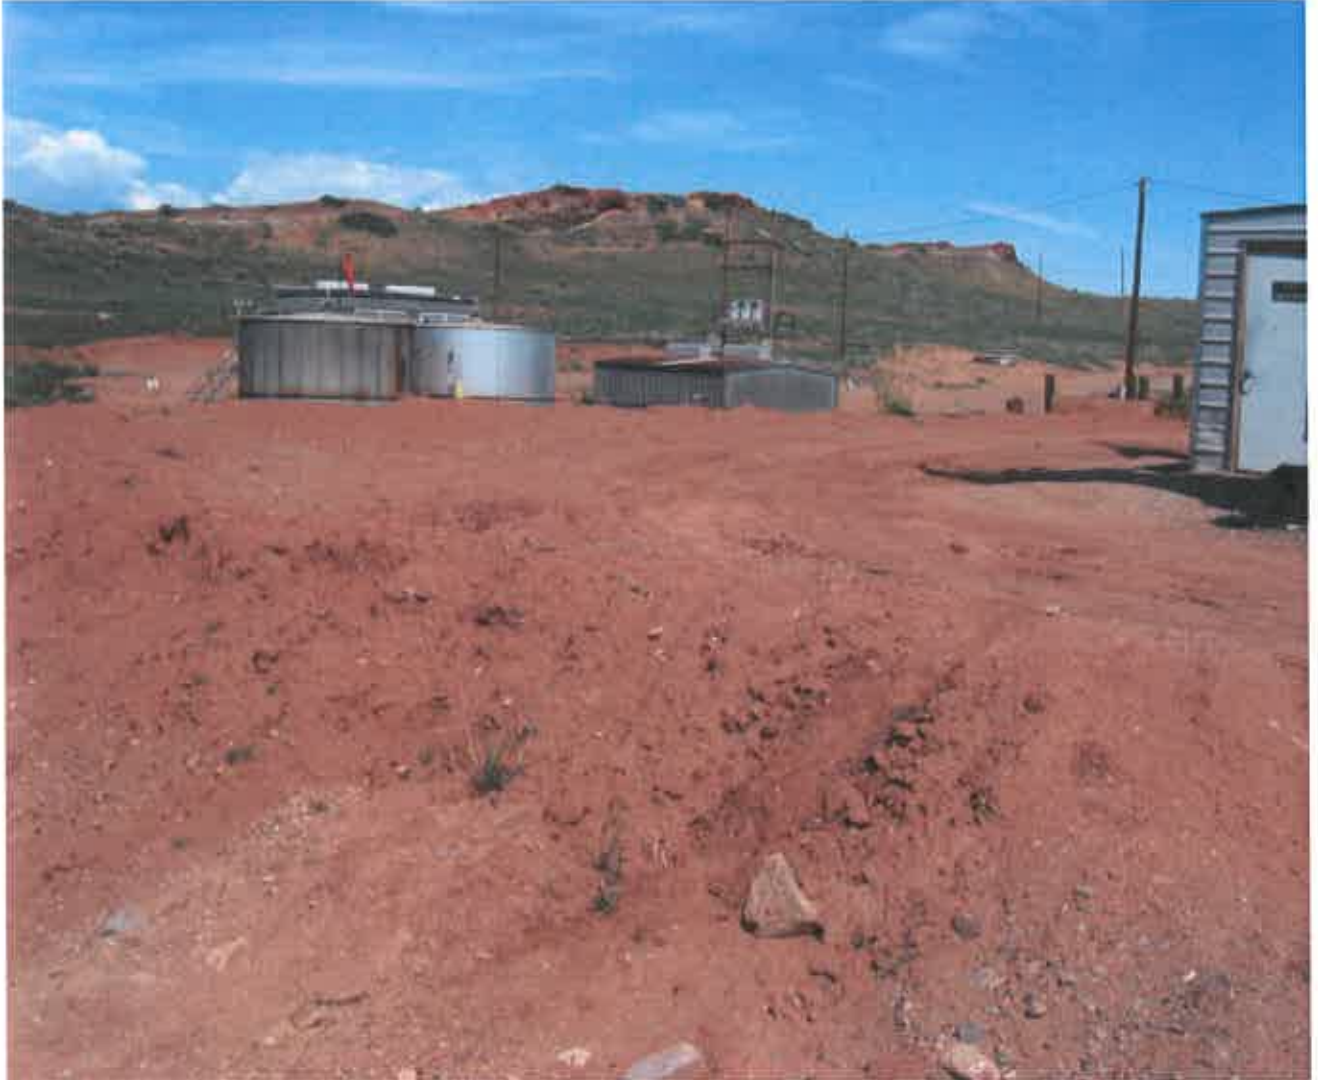
28: Perspective to northwest with 2 X 1000 gallon field constructed bolted steel produced water ASTs and top of header house, as this sector in located below grade of access road and HTs.

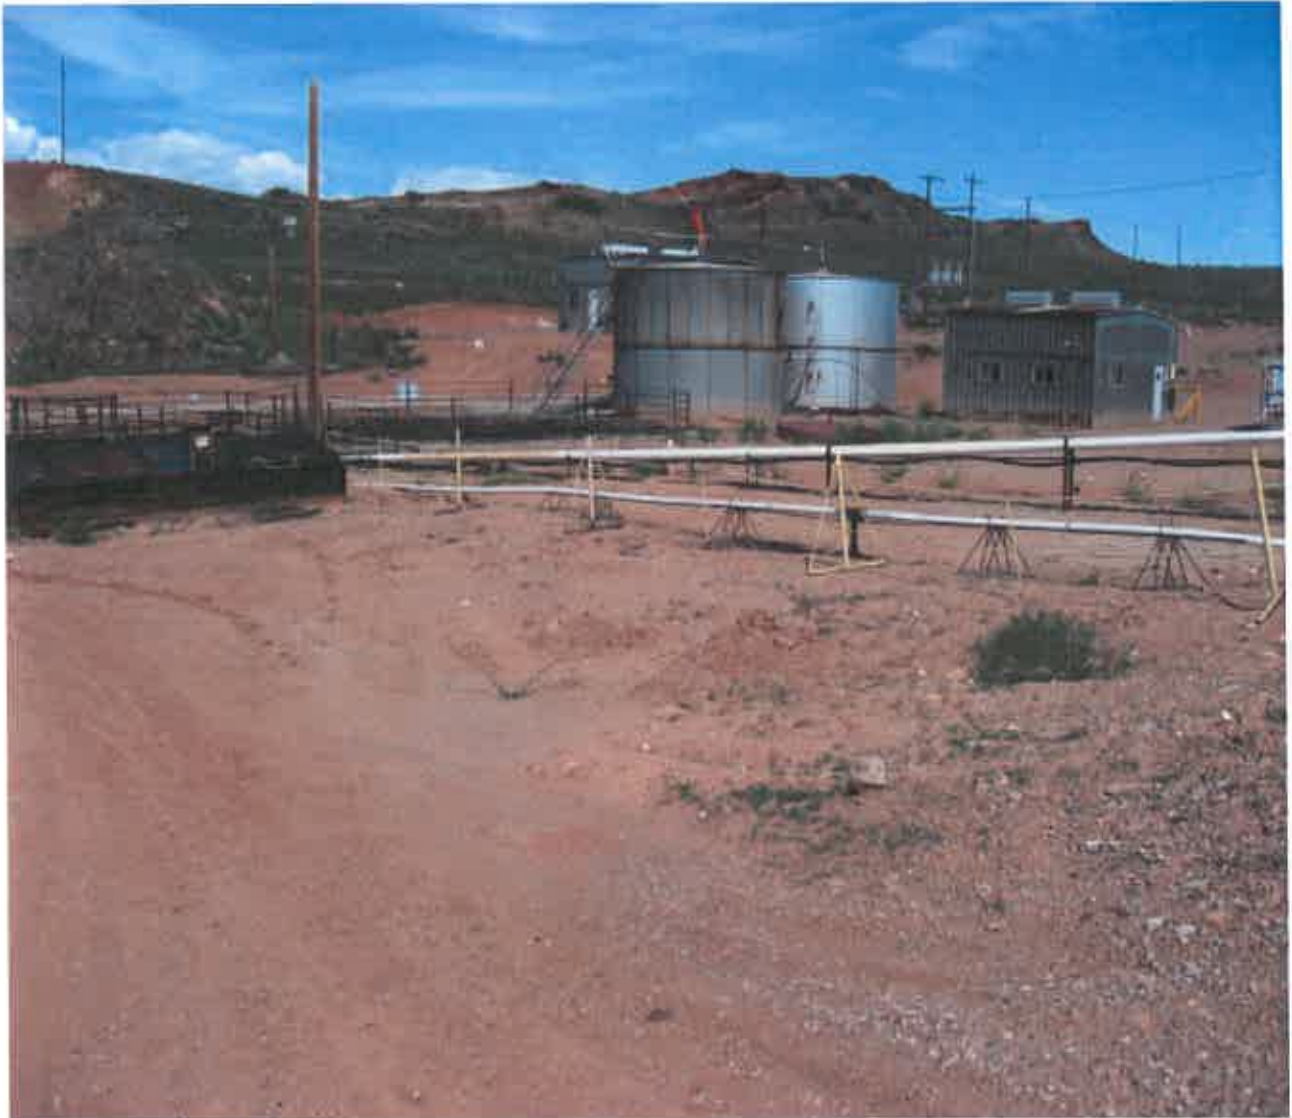
29: Perspective of incoming piping of produced water , with 2 X 1000 gallon field constructed bolted steel ASTs, header house with control panel just at right border of the photo. Also concrete and wooden pits, working evaporation/ storage ponds are visible at left of photo. Perspective is northwest.

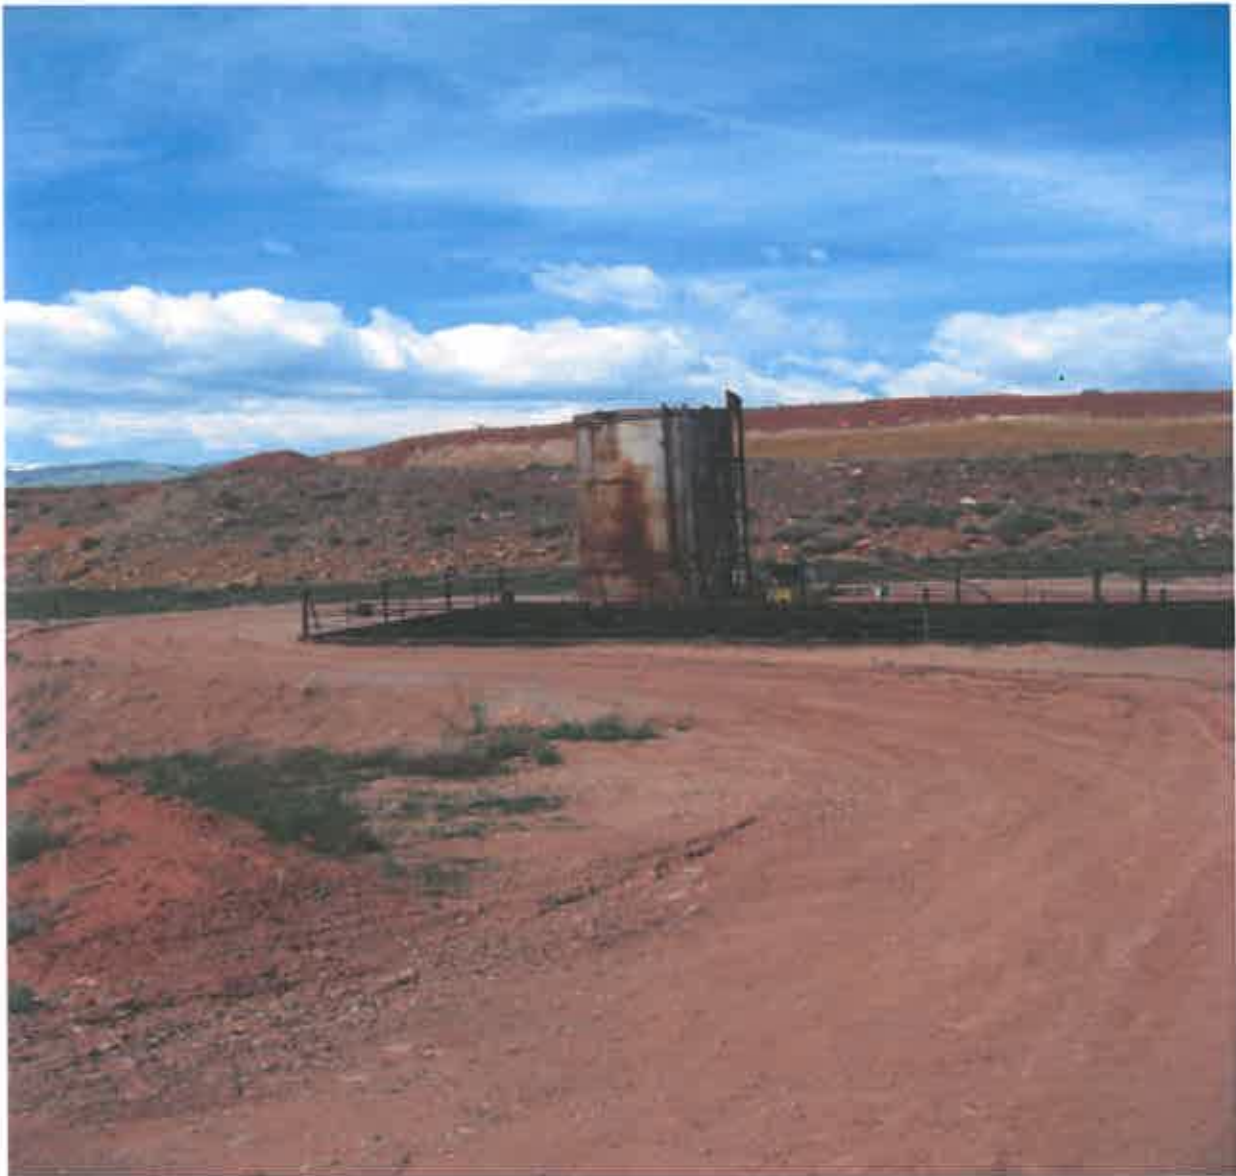
30: 400 bbl rusty AST containing (frac tank) skim oil located at southern end of the wooden pit, the second downhill evaporation/storage pond.
WESCO/ Lander field **W 13008** 6 June 2013

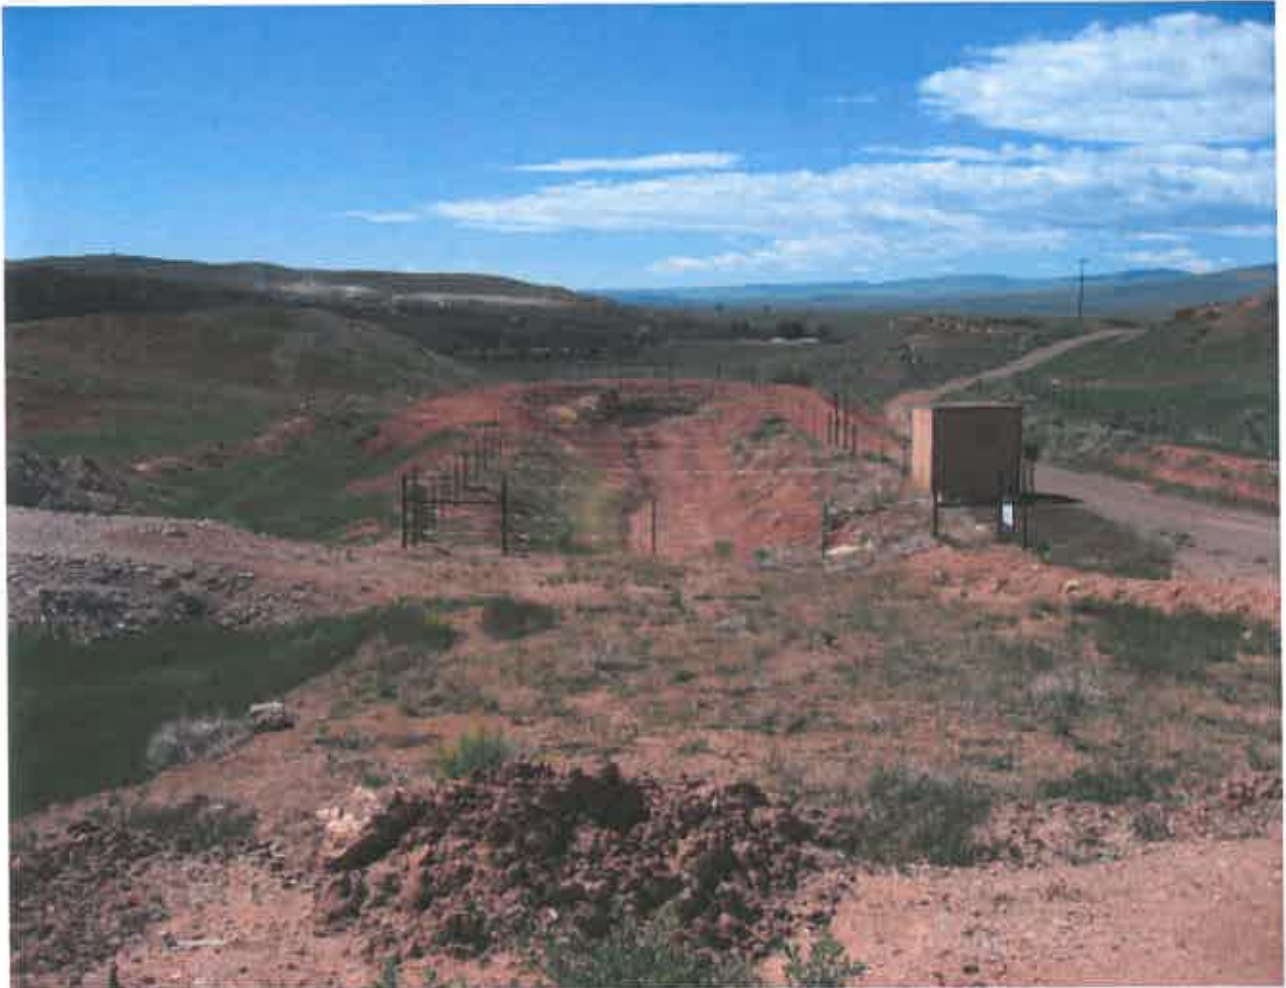
31: View of recycle pump building at the west edge of the long pit which is the earthen last pit for spills and overflows of produced waters, access to pit guided by secondary containment berm walls. Note wires stretched across above the long pit with pennants to discourage waterfowl from landing if there if pit becomes flooded. Perspective is south.

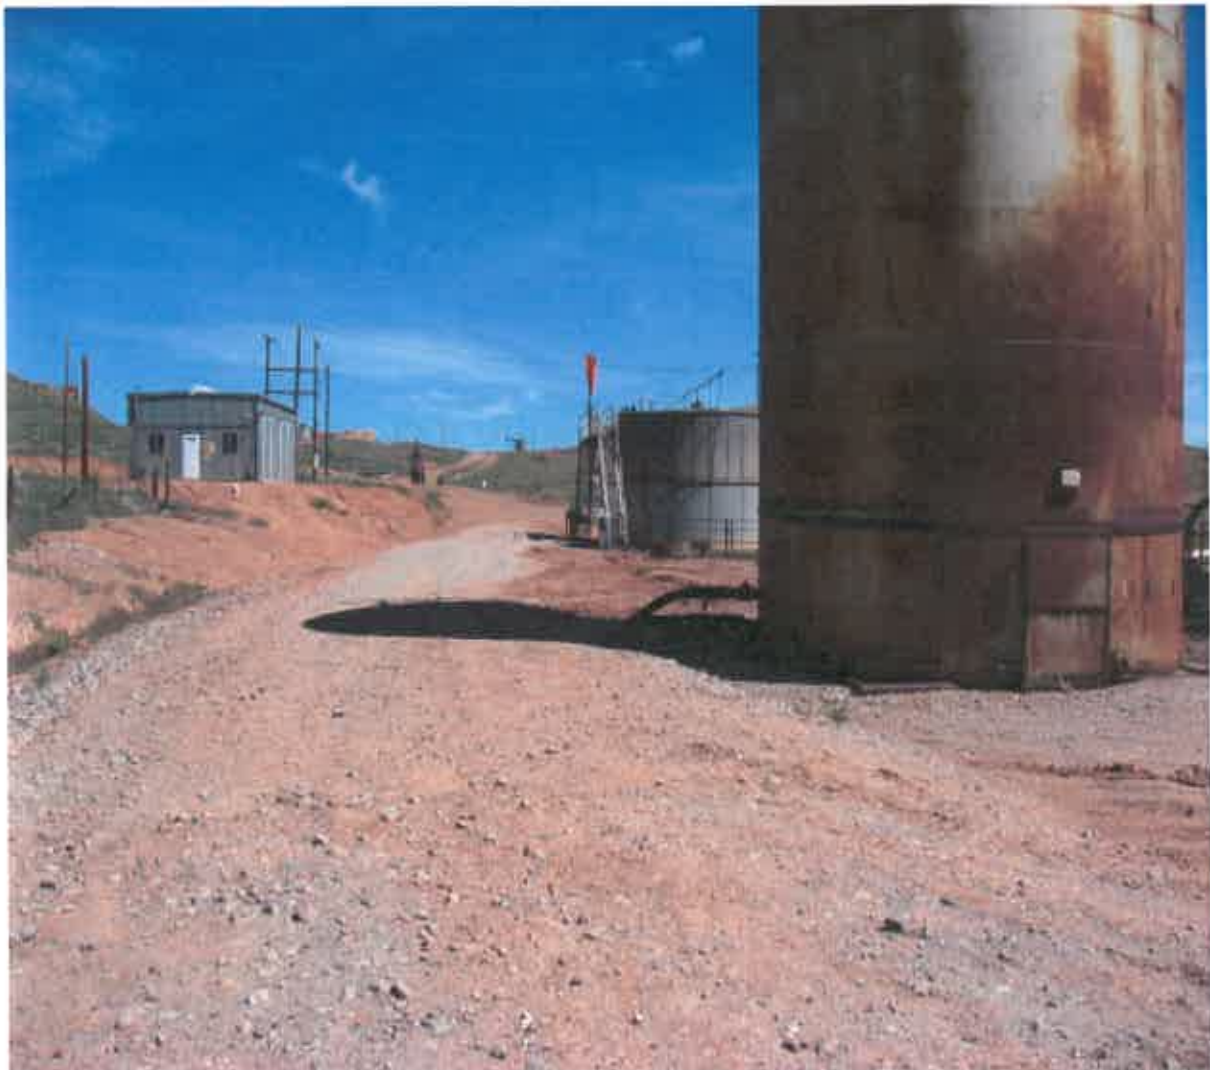
32: View of elevated access road going north, 400 bbl frac tank containing skim oil and 2 X 1000 gallon field constructed steel bolted water tanks. WESCO/ Lander field **W 13008** 6 June 2013

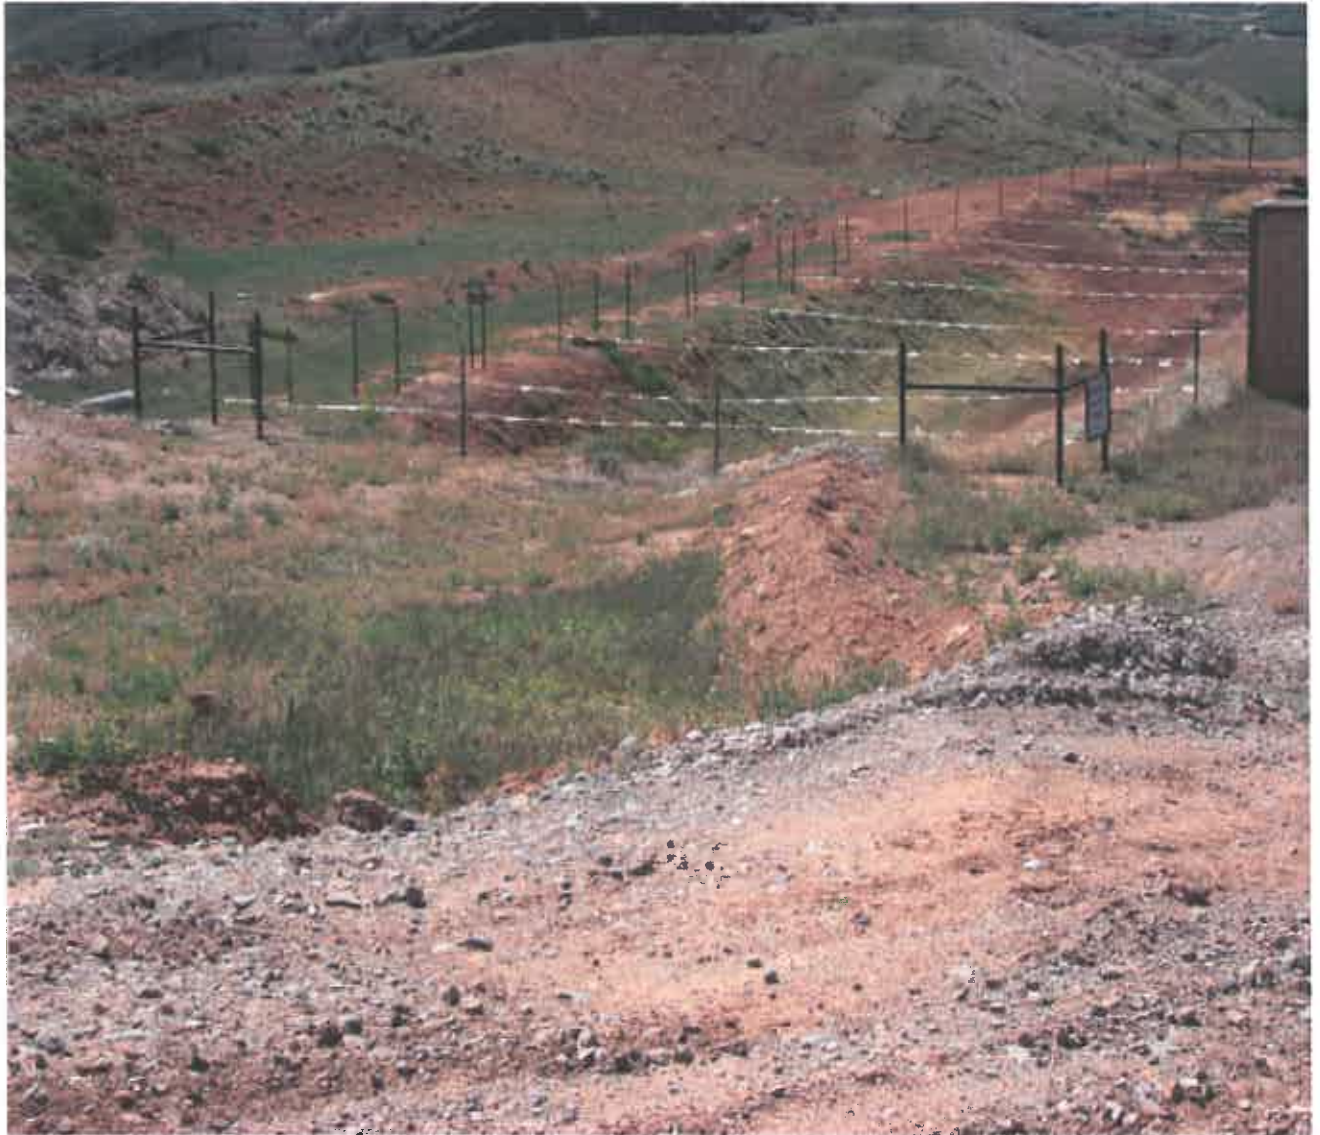
33: The long pit-emergency containment basin with recycle pump building barely visible at right side of photo. Pit is fenced , has wiring strung across with pennants to discourage any waterfowl landings. Secondary containment berm walls evident to direct any spillage flow directly into the pit. WESCO/ Lander field **W 13008** 6 June 2013

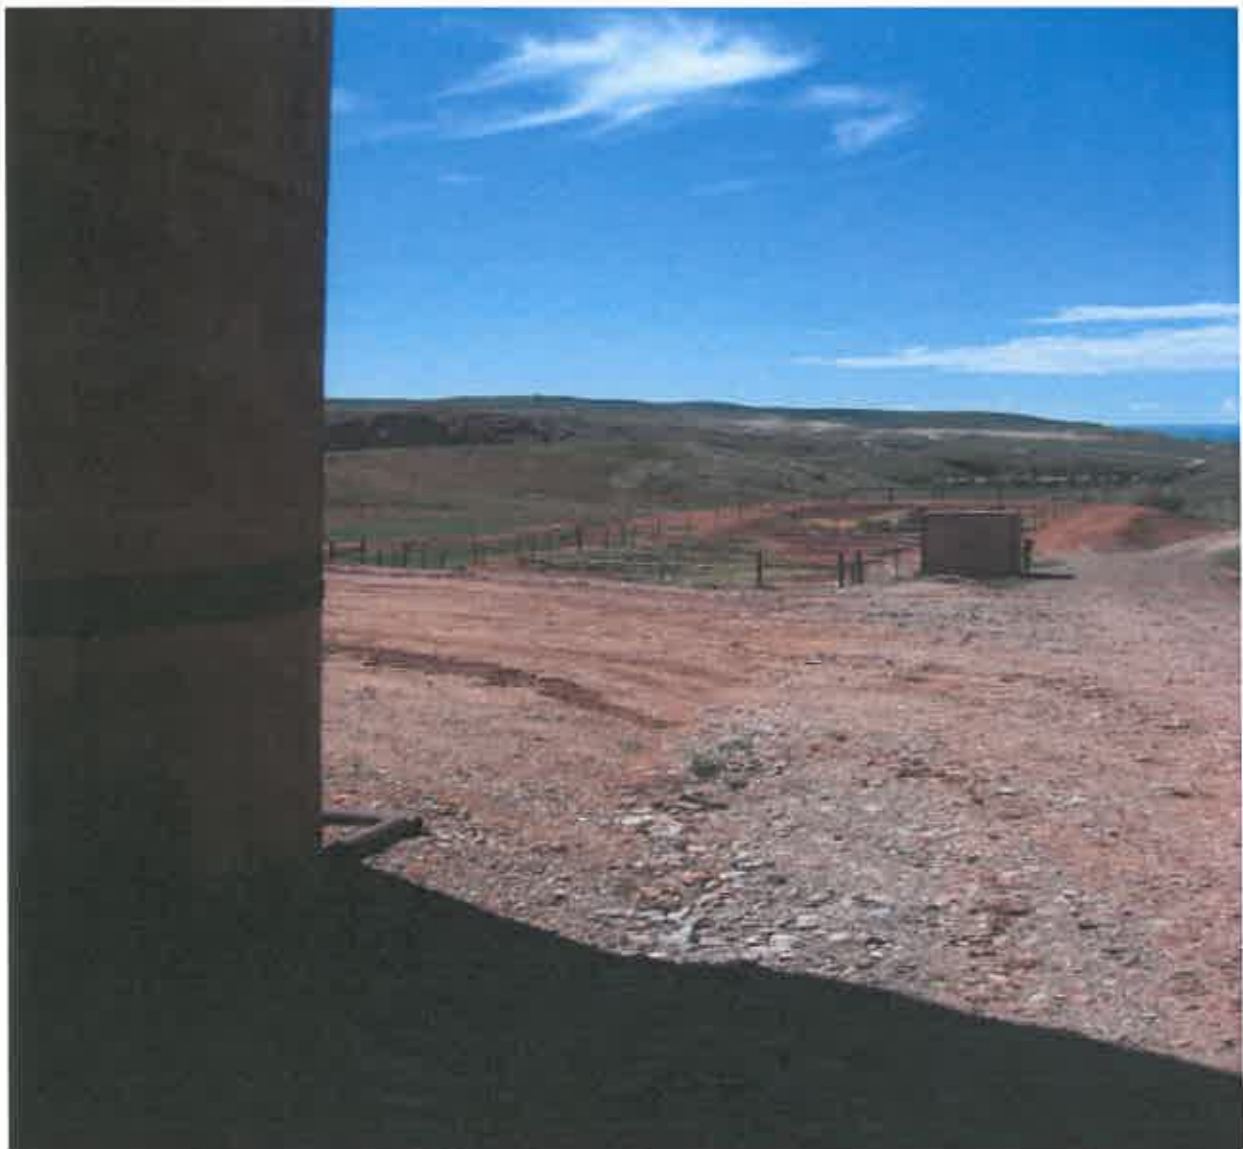
34: Perspective to south, view of the long pit; access roads, and recycle pump building. Photo taken from side of 400 bbl frac tank containing skim oil.
WESCO/ Lander field **W 13008** 6 June 2013
